FLOODPLAIN MANAGEMENT PLAN

Monterey County, CA

2014 Update

Prepared by:
Monterey County Water Resources Agency

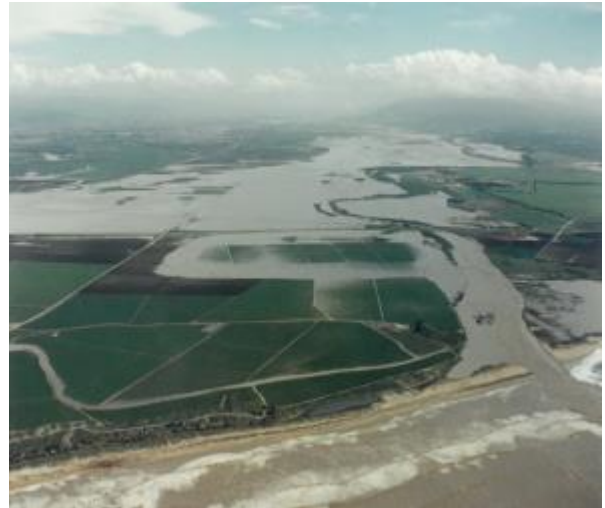
Figure 3: Salinas River Photo, March 1995

In January 1995, Monterey County experienced prolonged and sustained precipitation resulting in extensive flooding throughout the region. Most river valleys were affected with major damage experienced in the Pajaro Valley and Carmel Valley. On January 9 and 10, 1995, Monterey County was subjected to an intense winter storm during which up to 6 inches of rainfall was received in some areas. The MCWRA rated the storm as a 10- to 20-year event.

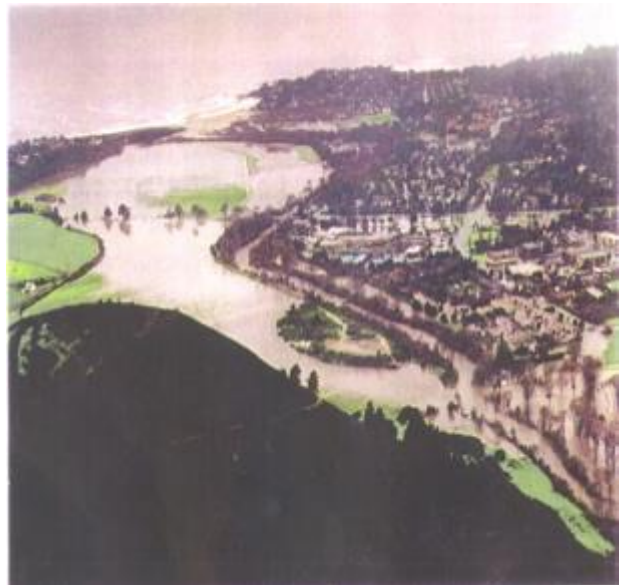
Figure 4: Carmel River Photo, February 1998

The most significant damage involved landslides and mudslides. In particular, the Las Lomas area experienced severe damage of eight residential parcels. Monterey County acquired the parcels

through the Federal Hazard Mitigation Grant Program and all structures were removed. Each parcel was subsequently rezoned to "open space" in perpetuity.

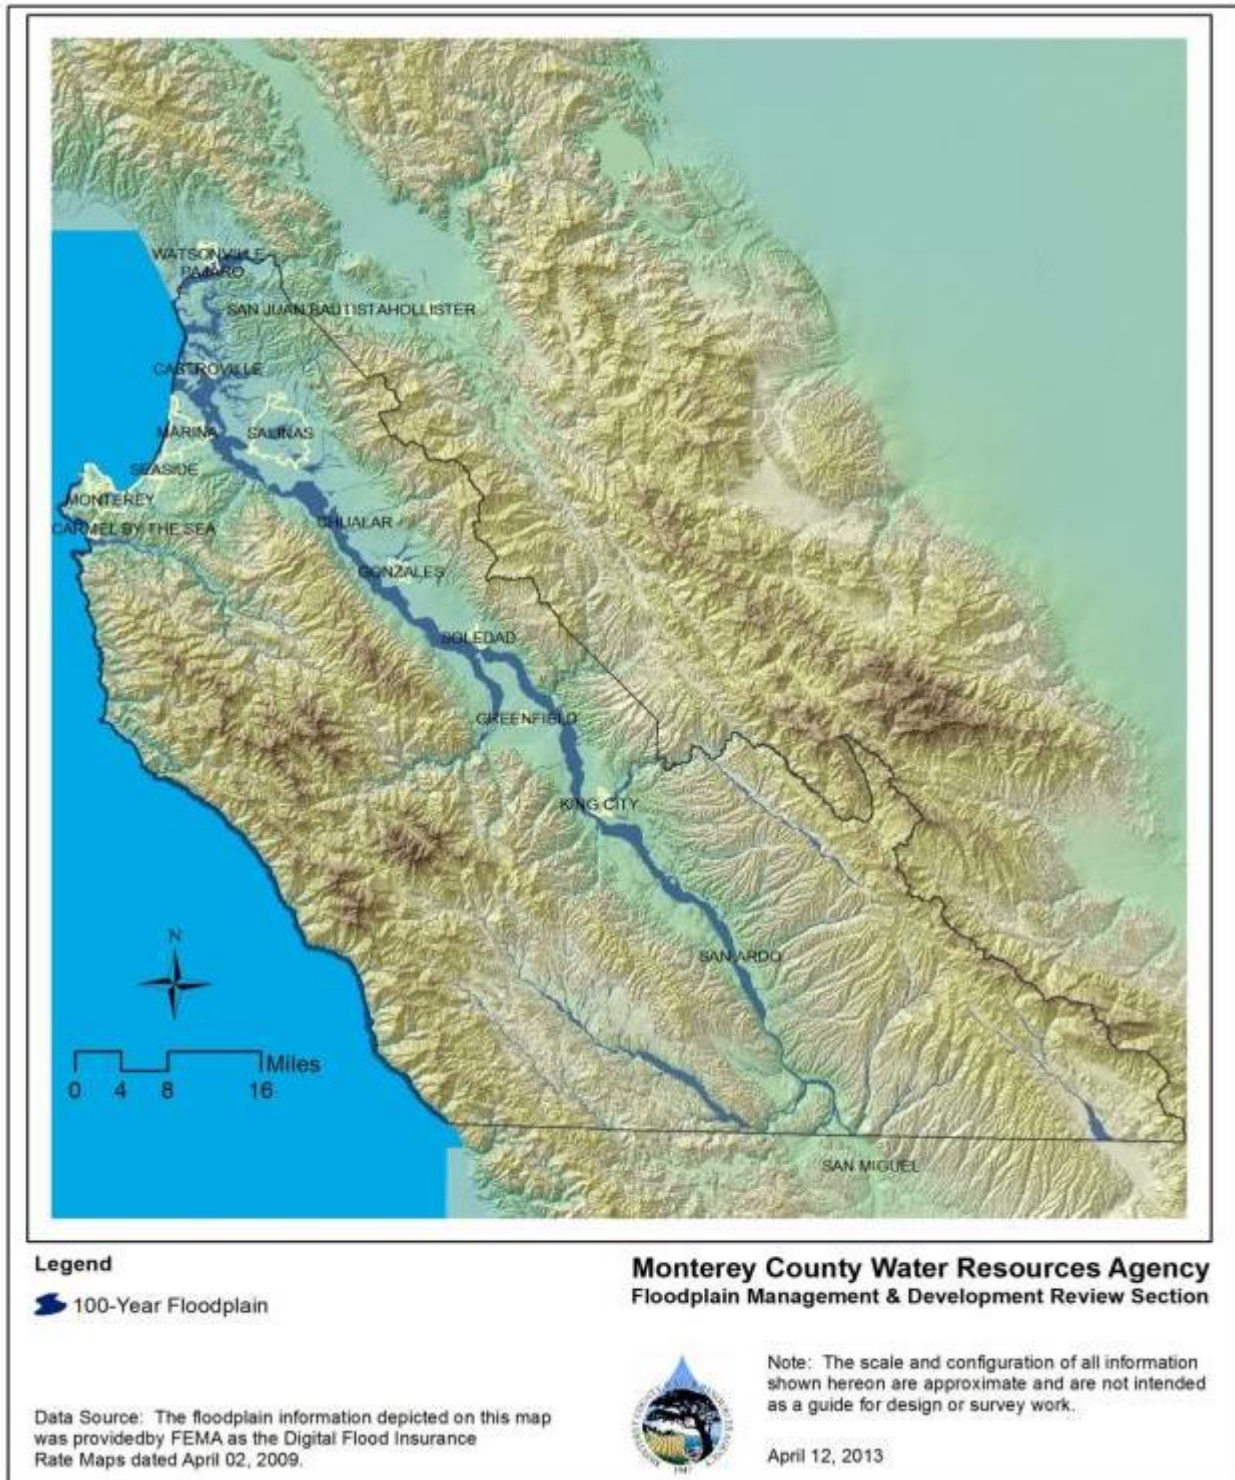
Figure 5: Monterey County FEMA-Defined Special Flood Hazard Areas

Paper maps are no longer used, as all flood hazard identification is performed through the use of DFIRMs. DFIRMs include layers such as base map data (streets, orthophotos, etc), base flood elevations, cross-sections with letter identifiers, floodway boundaries, and Letters of Map Change.

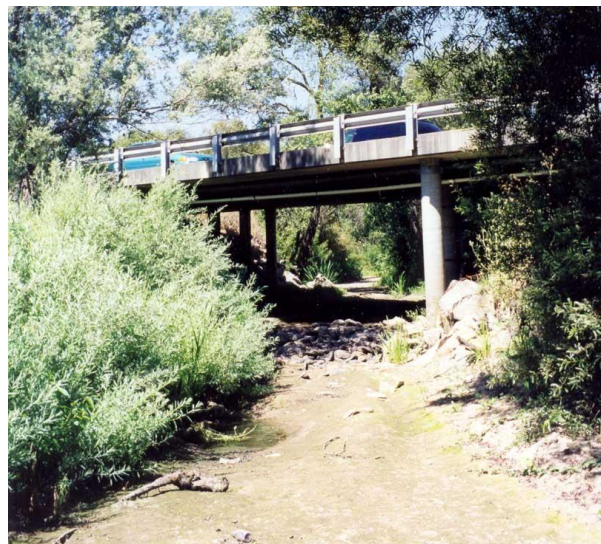
Figure 6: Carneros Creek at San Miguel Canyon Road, July 1998.

Carneros Creek RL Area: The 100-year flooding velocities for Carneros Creek range from 0.1 to 10.2 feet per second according to the FEMA Flood Insurance Study (FIS). The drainage area and peak discharge, at select locations, are provided in Appendix B.

RL Property No. 96 is located approximately 0.25 miles downstream from the intersection of San Miguel Canyon Road and Carneros Creek. Figure 6 was taken looking upstream toward San Miguel Canyon Road.

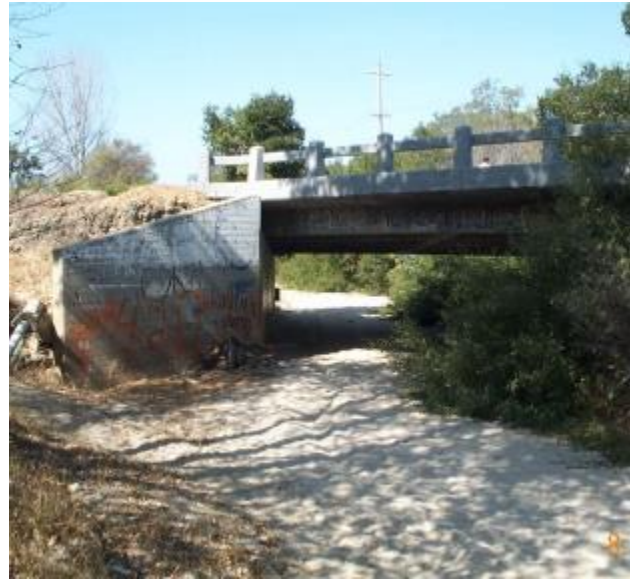
Figure 7: El Toro Creek, August 2002

Most of the higher areas are mountainous with slopes averaging about 50 percent. They are penetrated by narrow alluvium filled valleys. Moving downstream toward Highway 68, these valleys widen and have more gentle slopes. The lowest portion of the watershed includes the El Toro Creek floodplain, which is the most highly urbanized area.

Most of the mountainous region is brush-covered, especially those parts facing south and west. However, there is forest on those portions of the watersheds receiving more rain and having shady slopes. In certain areas the soil is granular and highly permeable, infiltrating a significant amount of precipitation. Large amounts of sediment and debris were deposited in the stream channel during the 1995 and 1998 floods resulting in increased flooding on lower El Toro Creek. The above photo, Figure 7 was taken several hundred feet downstream from Creekside Condominiums looking downstream.

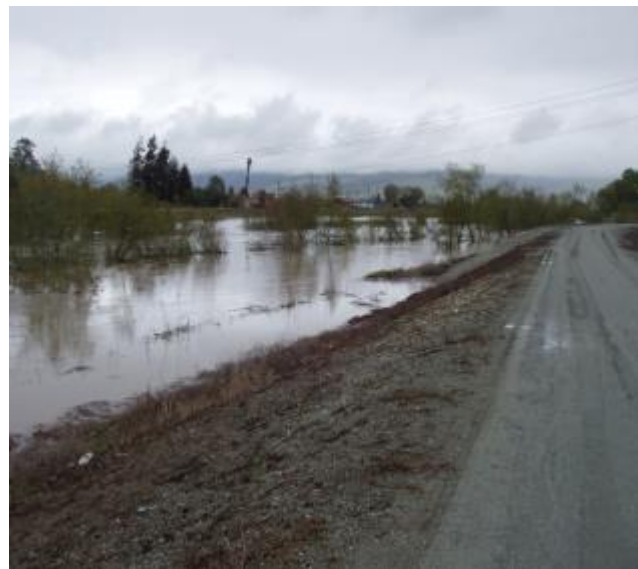
Figure 8: Pajaro River near Gonda Street, March 2011.

Pajaro River: Although there are no RL Properties along the Pajaro River, there has been historical flooding that has damaged many properties. The Pajaro Valley drainage basin separates the southern Santa Cruz Mountains to the north from the Gabilan Range to the south and extends east to the California Coast Range of mountains. The Pajaro River is the largest stream in the Pajaro Valley, draining approximately 1,190 square miles above the gage at Chittenden. Streams tributary to the Pajaro River include the Corralitos, Salsipuedes, Brown’s Valley, Green Valley, Casserly, and Pescadero Creeks, which drain the southern slopes of the Santa Cruz Mountains. Tributaries to the Pajaro River that are outside of the Pajaro Valley include the Uvas and Llagas Creeks (draining the eastern slope of the Santa Cruz Mountains), Pacheco Creek, and the San Benito River in San Benito County. The river ultimately flows into the Pacific Ocean at Monterey Bay, just south of the City of Watsonville. The drainage area and peak discharge, for select locations, are provided in Appendix B.

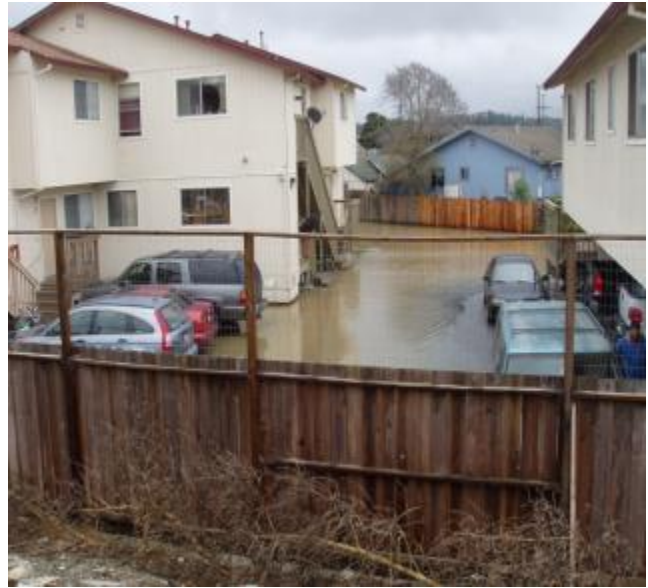
Figure 9: Shallow flooding at the Pajaro River Levee near Gonda Street , March 2011.

Flood damage in Pajaro Valley is caused by the overtopping or destruction of levees resulting in inundation of the floodplain. As provided in the FIS, 100-year flooding velocities range from 1.4 to 10.5 feet per second. The two largest floods on the Pajaro River occurred in 1955 and 1958. The associated discharges on the Pajaro River for these events were 24,000 cfs and 23,500 cfs, respectively, at the USGS Chittenden gage. The estimated return periods for these floods are 27 years and 26 years, respectively. Another severe flood occurred in March 1995, estimated to be a 10-20 year storm event, caused by a breach in the levee approximately 3 miles upstream of the town of Pajaro. The drainage system in the flat town could not adequately discharge the stormwater runoff in the streets. This resulted in mass evacuations and damage to private property. All residences (600+) and businesses in Pajaro were damaged and 2,500 people (out of a total population of 5,000) were evacuated. The peak flow travel times at the USGS Chittenden gage are provided in Appendix B.

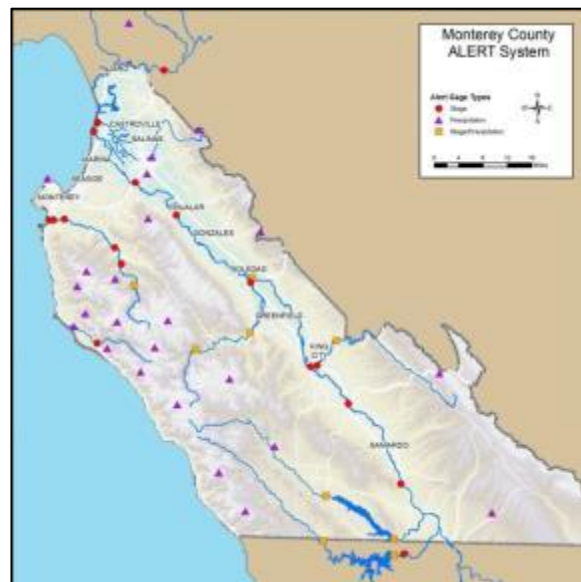
Figure 12: Monterey County ALERT Stations

Monterey County began the installation of one the first ALERT flood warning networks anywhere following the 1977 Marble Cone fire. ALERT (Automated Local Evaluation in Real Time) is a communications protocol that was developed by the National Weather Service in the 1970's. ALERT is a reliable, low-cost method of transmitting environmental data from remote sites to a central database in real time. The MCWRA operates and maintains the current Monterey County ALERT flood warning system. The system consists of approximately 50 remote sites located throughout the major watersheds of Monterey County. These remote sites measure a variety of environmental factors including rainfall, water level, and air temperature that are used to forecast flooding and monitor storm events.

Data from the ALERT system can be monitored by the MCWRA staff through a secure web-based interface from any computer or mobile device with internet access and a web browser. The modern web-based system, in conjunction with the redundant ALERT radio backbone, allows reliable access to real time hydrologic data in even the worst storm conditions. Data from the Monterey County flood warning system is used to support flood monitoring operations by the MCWRA as well as the National Weather Service and the California Nevada River Forecast Center.

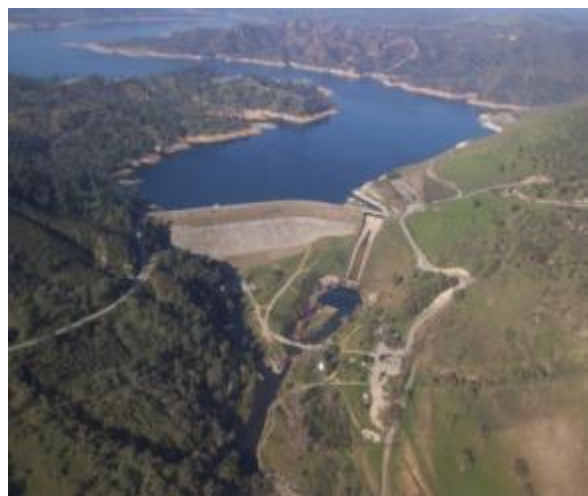
Figure 13: Nacimiento Dam

Nacimiento Dam and its reservoir, Nacimiento Reservoir, are located in northern San Luis Obispo County, about 20 miles from the coast, in central California. Nacimiento Dam was completed in 1957. This earth-filled dam has a height of 215 feet above the streambed and a crest length of 1,650 feet. The crest elevation is 825 feet above mean sea level (msl) with a spillway elevation of 787.75 feet which can be raised to an elevation of 800 feet by the use of an inflatable Obermeyer spillway gate. When the reservoir is full (elevation 800 feet), it has a maximum storage capacity of 377,900 acre-feet, is 18 miles long, and has about 165 miles of shoreline. The maximum elevation during flood stage is 825 feet, with a maximum temporary capacity of 538,000 acre-feet and a temporary surface area of 7,149 acres. Nacimiento Dam is under the jurisdiction of the DWR DSOD and the FERC. The FERC has jurisdiction over the project due to the existence of the hydroelectric plant. Nacimiento Dam was constructed and is owned MCWRA. It serves as a flood control, water conservation, and recreation facility.

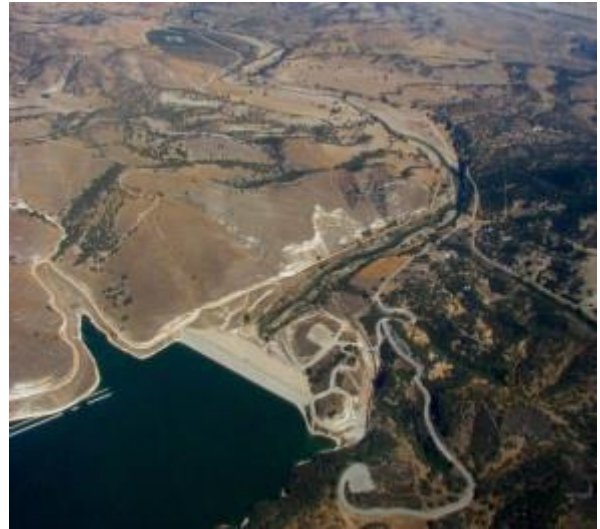
Figure 14: San Antonio Dam

San Antonio Dam and its reservoir, San Antonio Reservoir, are located in southern Monterey County, about 16 miles northwest of Paso Robles, in central California. San Antonio Dam was completed in 1967. This earth-filled dam has a height of 201 feet above the streambed and a crest length of 1,433 feet. The crest of the dam elevation is 802 feet above msl with a spillway crest elevation of 780 feet and a capacity of 35,400 cfs. When the reservoir is full (elevation 780 feet), it has a maximum storage capacity of 335,000 acre-feet, is 16 miles long, and has about 100 miles of shoreline. The maximum elevation during flood stage is 802 feet, with a maximum temporary capacity of about 477,000 acre-feet and a temporary surface area of about 7,500 acres. San Antonio Dam is under the jurisdiction of the DSOD. Like Nacimiento Dam, San Antonio Dam was constructed and is owned MCWRA. It serves as a flood control, water conservation, and recreation facility.

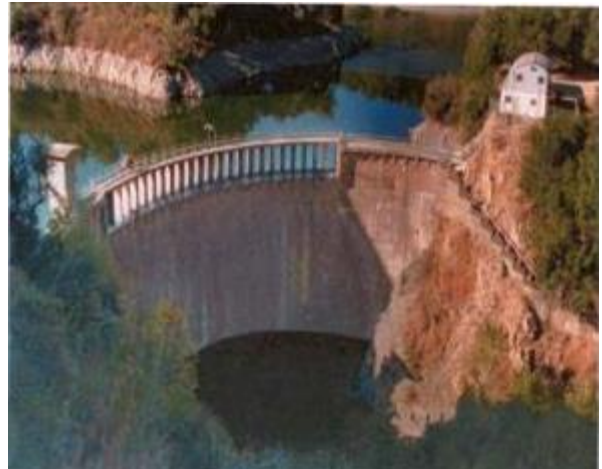
Figure 15: San Clemente Dam

The San Clemente Dam, constructed in 1921, is located 18 miles upstream of the ocean, and once provided drinking water throughout the Monterey Peninsula. It is a concrete arch dam with a 300-foot crest, 106 feet above the bedrock and 65 feet above the streambed. When the dam was constructed, it had a reservoir storage capacity of approximately 1,425 acre-feet. Today the reservoir has been filled by more than 2.5 million cubic yards of sediment, leaving a reservoir storage capacity of approximately 70 acre-feet.

The California Department of Water Resources issued a safety order for the dam structure early in 1991, determining that San Clemente Dam could potentially fail in the event of either a major earthquake or flood.

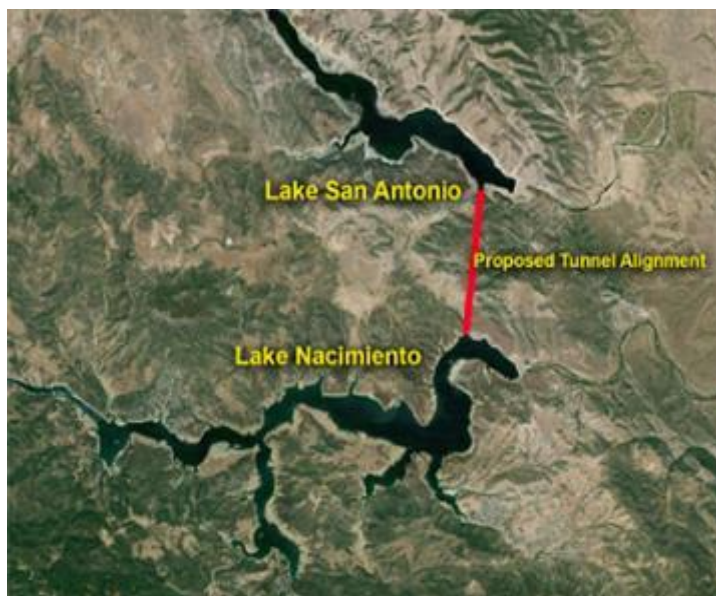
Figure 18: Proposed approximate tunnel alignment.

The Interlake Tunnel Project (Interlake Tunnel) has been under consideration since 1978 as a way to manage flood control releases from Nacimiento Reservoir. The Interlake Tunnel was later included in the July 1991 Water Facilities Capital Plan prepared by Boyle Engineering Corporation for the MCWRA. Operationally, the Interlake Tunnel would divert water from Nacimiento Reservoir to San Antonio Reservoir that would have otherwise been spilled at Nacimiento Dam. The Nacimiento River basin produces nearly three times the average annual flow of the San Antonio River basin; therefore, capturing high Nacimiento River flows and diverting those flows to San Antonio Reservoir increases the overall storage capacity of the system.

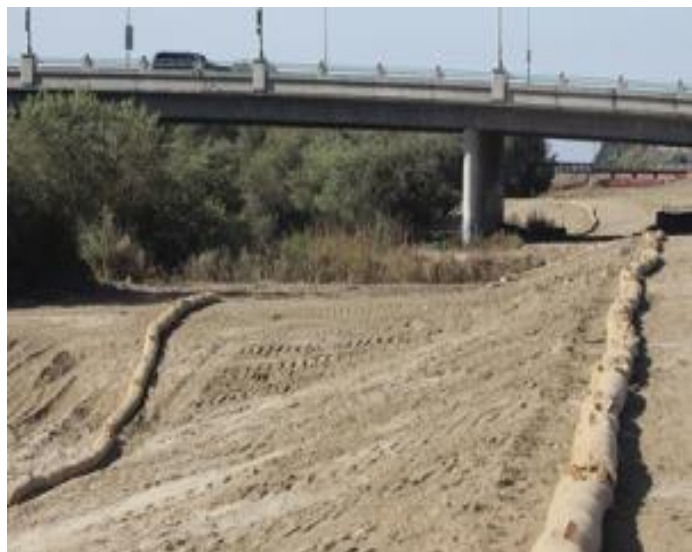
Figure 19: Phase I photo of bench excavation on the Pajaro River.

The Pajaro River Bench Excavation Project is a multi-jurisdictional effort to improve the channel conveyance of the Pajaro River. The City of Watsonville, Santa Cruz County, and Monterey County are cooperating in the effort to excavate portions of the water side of the levee and benches to increase the system’s capacity by 10% and to decrease the intensity and severity of floods. The total project cost is approximately \$6.5 million,

with \$3.5 million made available through local contribution and the remaining \$3 million from the Prop. 84 Local Levee Assistance Program. The project is being implemented in two phases by the Santa Cruz County Department of Public Works. The estimated completion date is late summer 2015.
